**HIGH STREET, SANDY  
CENTRAL BEDFORDSHIRE**

**PROPOSED ZEBRA CROSSING**

**COMBINED STAGE 1&2 ROAD SAFETY AUDIT**

Dated	19 <sup>th</sup> November 2021
Registration Code:	8704
RJ HUB:	12213101190300014
DM Ref:	N/A

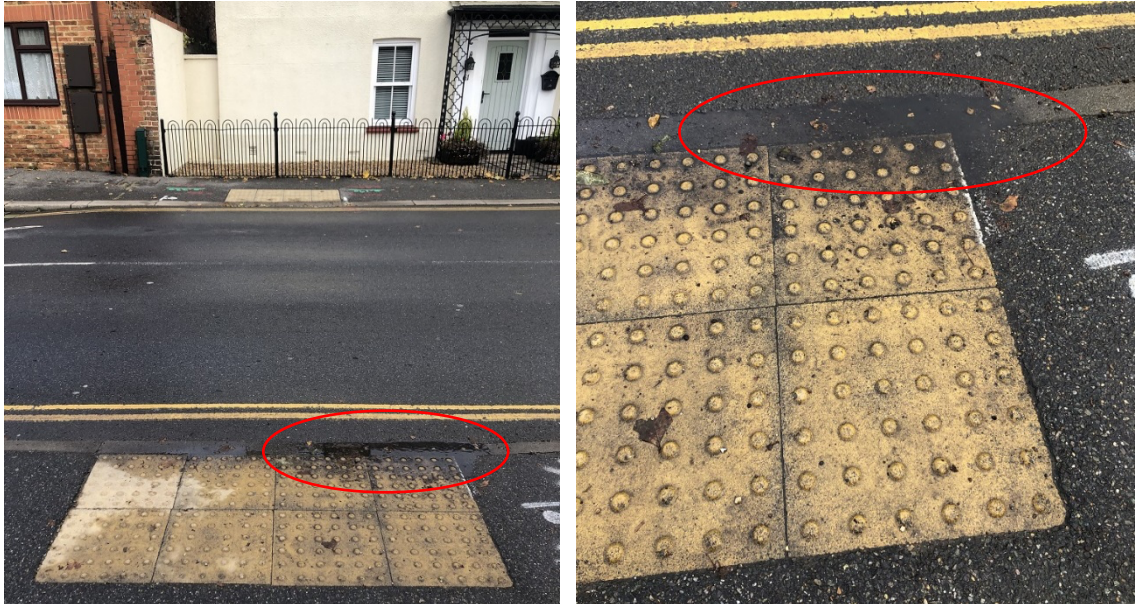
**Location:** South side of proposed Zebra crossing point.

**Summary:** Risk of road user loss of control collisions and/or pedestrian slip / fall type incidents associated with inadequate drainage on the southern side of the proposed crossing / crossing carpet.

Evidence of the formation of standing water / ponding was noted during the site visit on the southern side of the existing uncontrolled crossing point, indicating a potential drainage issue. Inadequate drainage provision can lead to the formation of standing water within the carriageway and/or pedestrian waiting. Areas of ponding within the carriageway increase the risk of loss of control / aquaplaning type collisions (potentially with secondary on-crossing type collisions). Additionally, should standing water form within the pedestrian waiting areas (i.e. within the tactile paving extents), crossing users may be susceptible to slip / fall type injury. The risk may be exacerbated during periods of heavy rain, inclement weather and/or icy conditions.

*Images 1 & 2 – Evidence of surface deposits and ponding*

It is recommended that the local drainage is reviewed by a drainage engineer and that, where appropriate, levels are adjusted and/or drainage detail revised accordingly to eliminate the issue of standing water within the carriageway or pedestrian waiting areas.

4.4	It is recommended that the local drainage is reviewed by a drainage engineer and that, where appropriate, levels are adjusted and/or drainage detail revised accordingly to eliminate the issue of standing water within the carriageway or pedestrian waiting areas.	<p>DO Response: Agree – The levels at the considered section are proposed to be raised and the kerbs are proposed to be relayed at 6mm upstand. Refer to enclosed drawing CBC-234912-000-001 – Revision C.</p> <p>OO Response: Agree with the revised levels. The resurfacing with covers the effected gully.</p> <p>Install with amended levels as per Drainage Drawing CBC-234912-000-001 – Revision A. This main road is part of subject gritting route will be gritted in line with Winter Service Plan. CBC will continue to monitor the area following the schemes implementation as part of the cyclic inspection regime.</p>	Designers Response Accepted.	No.

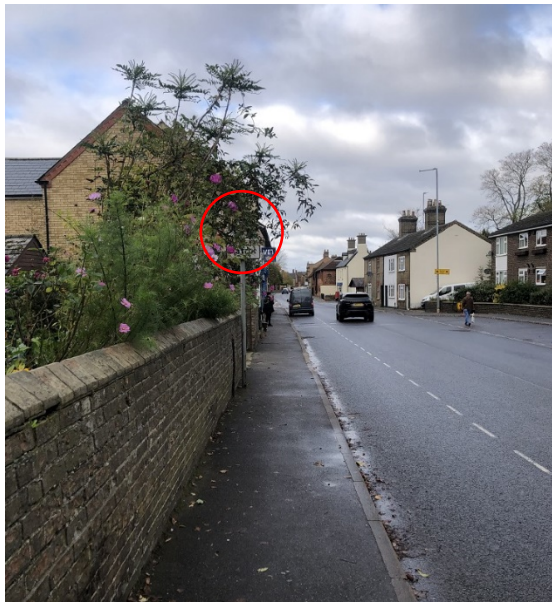
**Location:** Eastern end of scheme – location of Road Sign TS4.

**Summary:** Vegetation within the southern verge (founded in private land) is obscuring the existing sign / location of proposed TS4.

Vegetation is currently obscuring the existing School sign (to TSRGD Diagram No.545). Under the scheme proposals the existing ‘Patrol’ subplate (also obscured) is to be replaced with a ‘School’ subplate. Obscuration of the proposed sign may result in road users failing to see / process the information conveyed and so unexpectedly encounter the hazard described by the sign. This could lead to sudden braking and/or collision with pedestrians (school children).

*Image 3 – Vegetation obscuring existing sign / proposed location of TS4*

It is recommended that the vegetation is cut-back / removed to afford unobscured forward visibility to the proposed road sign (liaison with landowners / property owners may be required).

4.12	<p>It is recommended that the vegetation is cut-back / removed to afford unobscured forward visibility to the proposed road sign (liaison with landowners / property owners may be required).</p>	<p>DO Response: Agree – The client (Lisa Wright) to contact the property owner (property number 48) to cut back the overhanging vegetation and instruct the owner to regularly maintain the vegetation.</p> <p>OO Response: Request has been sent to instruct the removal of the vegetation that is obstructing the signage and for this to be maintained.</p> <p>CBC to confirm the vegetation has been removed by the property owner and if no carry out the removal by the Highways Area Team.</p>	Designers Response Accepted.	No.

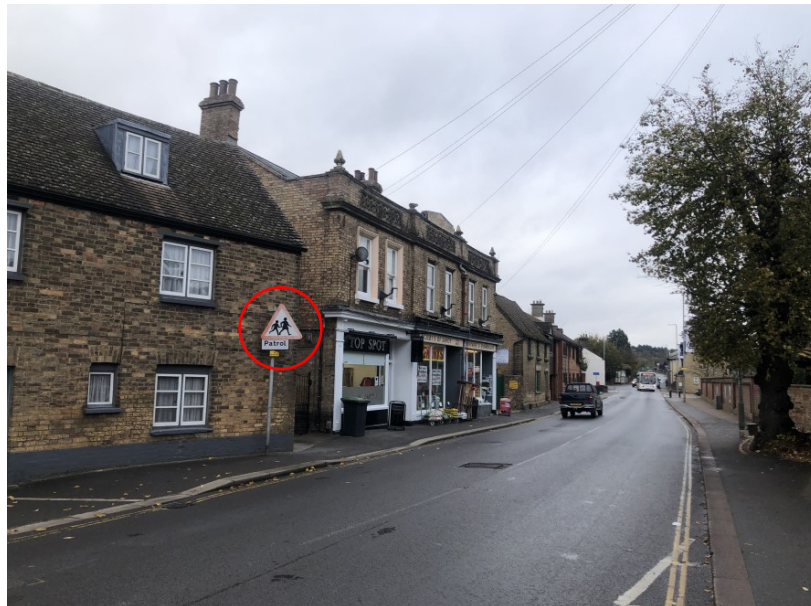
- 5.1 Some of the existing sign faces (notably to TSRGD Diagram No.545) are faded and in poor condition. These sign faces are to be retained under the scheme proposals (TS3 & TS4), with only subplates being revised/replaced. It is suggested that the main sign faces are replaced to enhance their conspicuity to approaching road users. In addition, it is noted that TS3 is to be located coincident with the narrowest part of the footway within this section. The existing sign has rotated about the post, possibly as a result of impact / buffeting effects from adjacent traffic flows and minimal lateral clearance to the carriageway edge. It is suggested that the location of this sign is reviewed and relocated to alleviate the risk of the signface being struck by passing LGV/PCV/deliveries.

*Image 4 – Rotation of existing sign at location of TS3*

5.1	<p>Some of the existing sign faces (notably to TSRGD Diagram No.545) are faded and in poor condition. These sign faces are to be retained under the scheme proposals (TS3 &amp; TS4), with only subplates being revised/replaced. It is suggested that the main sign faces are replaced to enhance their conspicuity to approaching road users. In addition, it is noted that TS3 is to be located coincident with the narrowest part of the footway within this section. The existing sign has rotated about the post, possibly as a result of impact / buffeting effects from adjacent traffic flows and minimal lateral clearance to the carriageway edge. It is suggested that the location of this sign is reviewed and relocated to alleviate the risk of the signface being struck by passing LGV/PCV/deliveries.</p>	<p>DO Response: Agree – The existing signs (at locations TS3 &amp; TS4) are removed and renewed with new signs. The sign TS3 is relocated on other side of the road to improve lateral clearance and visibility. Refer to enclosed drawing CBC-234912-000-001 – Revision C.</p> <p>OO Response: Agree designers' response.</p> <p>Install revised signage as per drawing CBC-234912-000-001 – Revision C.</p>	Designers Response Accepted.	No.

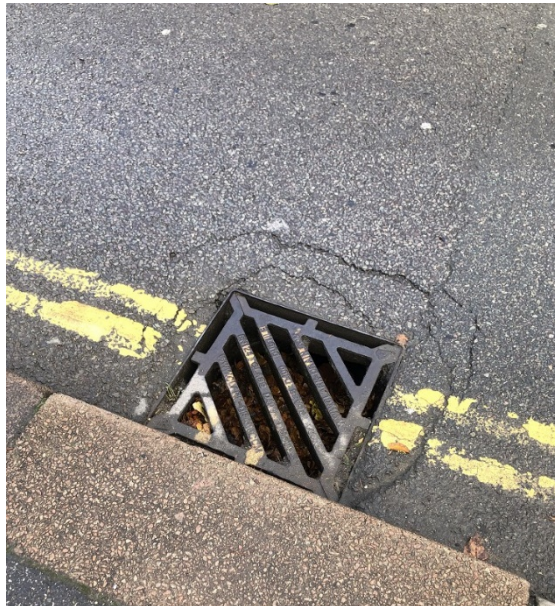
*Image 5 – Carriageway defects surrounding partially blocked gully west of crossing (south side of B1042)*

5.4	<p>Carriageway depressions (settlement cracking) is noted around an existing road gully west of the proposed crossing point on the southern side of the B1042. There is also evidence that the gully may be blocked. It is suggested the gully is cleaned and the carriageway defects repaired as part of the scheme.</p>	<p>DO Response: Agree – The cracking will be repaired as part of the scheme surfacing works (refer to enclosed drawing CBC-234912-000-001 – Revision C) and the gully cleaning works will be carried out as part of the scheme or part of the CBC maintenance work.</p> <p>OO Response: Agree designers' response.</p> <p>Resurface as per Drawing CBC-234912-000-001 – Revision C. CBC will continue to monitor the area following the schemes implementation as part of the cyclic inspection regime.</p>	Designers Response Accepted.	No.

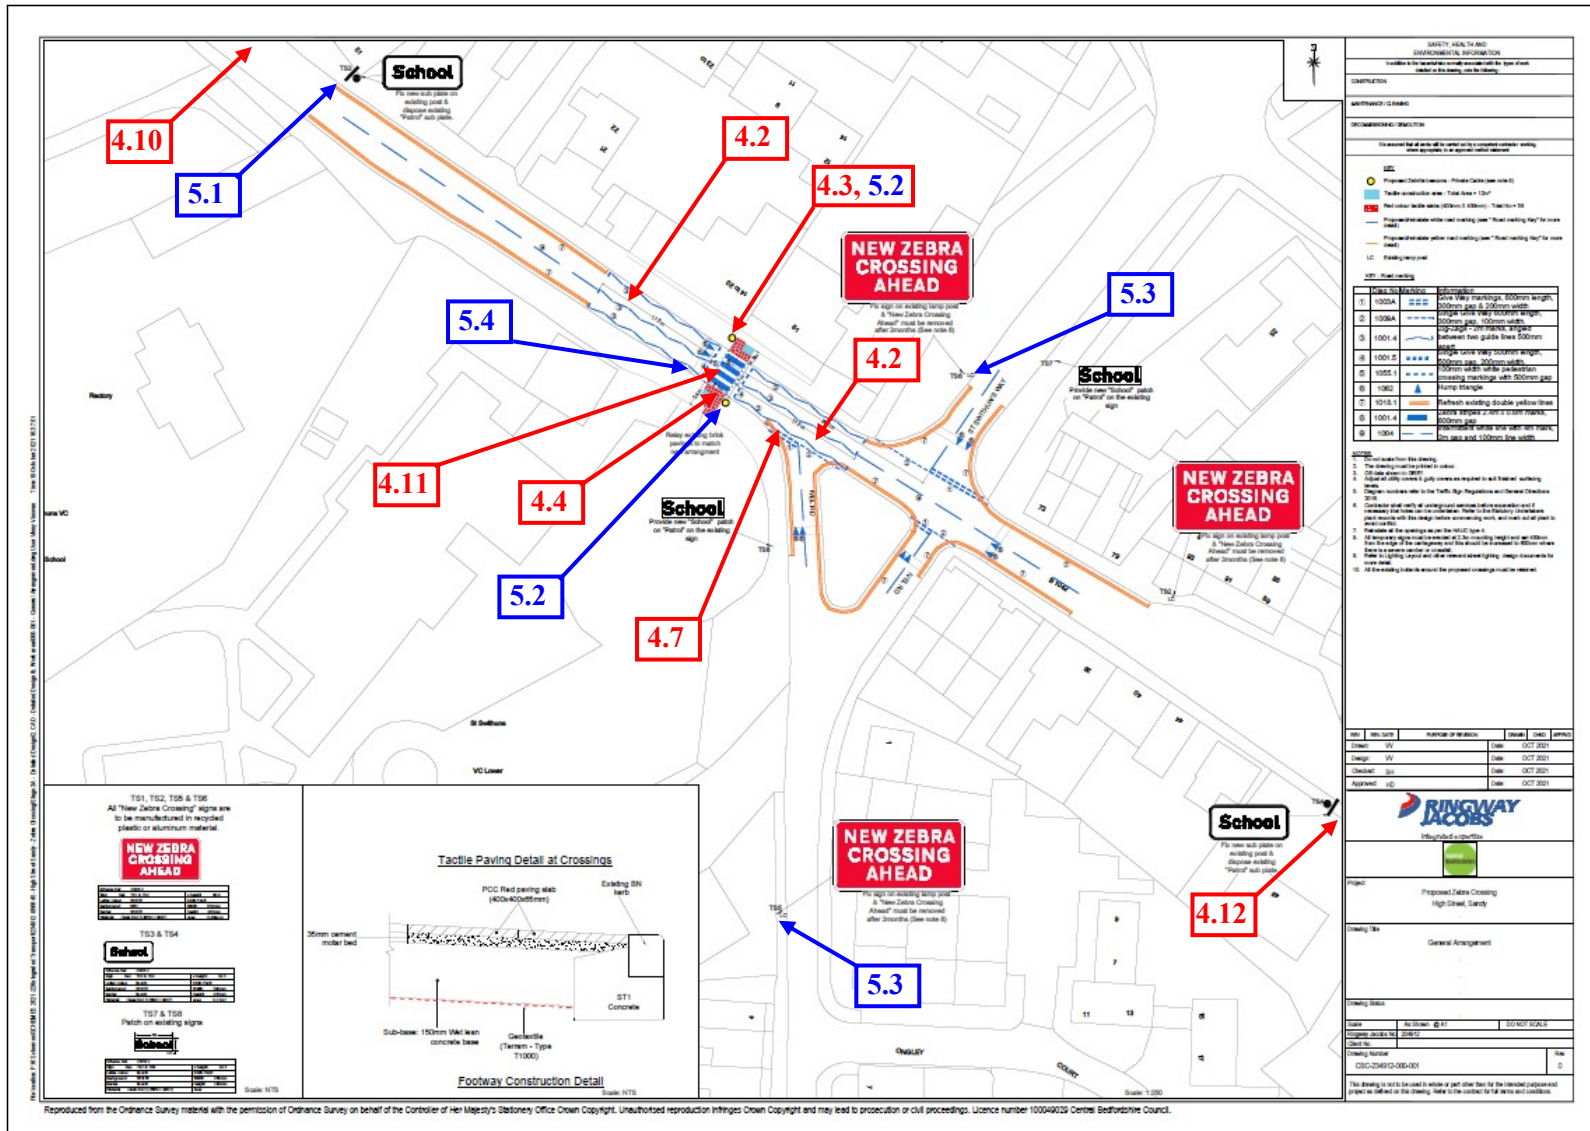
# 7.0 COMBINED STAGE 1&2 ROAD SAFETY AUDIT – PROBLEM LOCATION PLAN

Additional Note 5.5 applies to the extents of the scheme
